Organ Pipe Cactus  
National Monument

## **Effects of the International Boundary Pedestrian Fence in the Vicinity of Lukeville, Arizona, on Drainage Systems and Infrastructure, Organ Pipe Cactus National Monument, Arizona**

Prepared August 2008

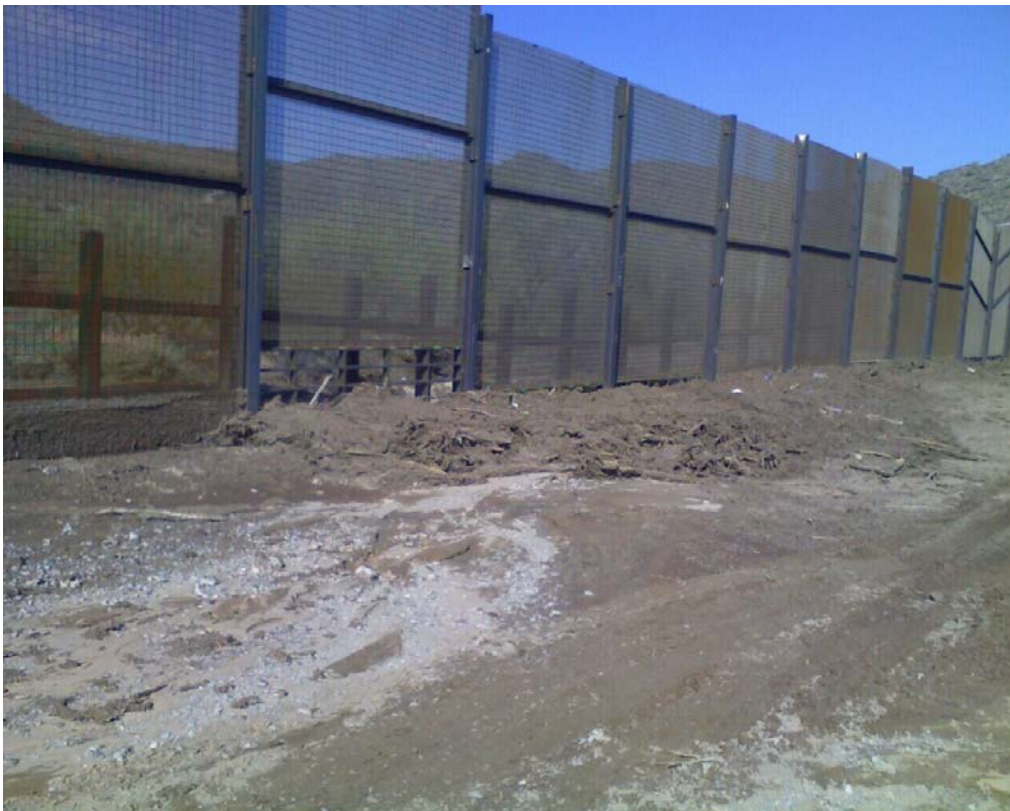
The pedestrian fence impeded the natural flow of water and did not properly convey floodwaters during the July 12 storm. Mainstem drainage channels contained flood flows until reaching the proximity of the pedestrian fence. Debris blockages formed at the upstream side of the fence, restricting water flow and causing significant water elevation rise (Figure 6). The foundation wall of the pedestrian fence stopped subsurface sediment flow, which added to the water elevation rise. Backwater flooding occurred in most washes.

Figure 6. At this drainage crossing west of Lukeville, debris filled most of the length of the drainage grate, causing backwater pooling of 1-2 feet depth. Photograph was taken on July 15, 2006.

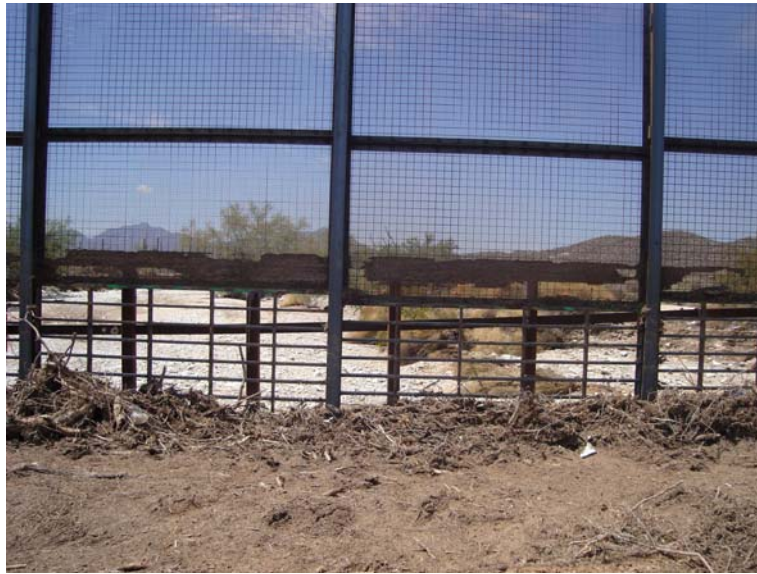
- Victoria Wash, with a drainage area of 5.6 square miles, rose against the pedestrian fence and flowed over 1,100 feet to the west into a minor channel. Fine sediment deposits on the fence between the two washes reached a height of 1-2 feet. Where the main channel crossed the fence, the high water mark was about 7 feet above the foundation wall of the fence (Figure 7). It is uncertain how much of this rise was due to the fence.
- Smugglers' Wash, with a watershed of nearly 15 square miles, left its channel at the pedestrian fence and flowed more than 500 feet to the east. It discharged into a channel that normally drains a 0.15 square mile basin.

Figure 7. The floodwaters of Victoria Wash (W13) were blocked by debris and rose to a depth of about 7 feet.

About 2 feet of coarse debris were deposited against the fence (upper photo, July 14, 2008). A band of fine sediment marks the high water line at flood stage.

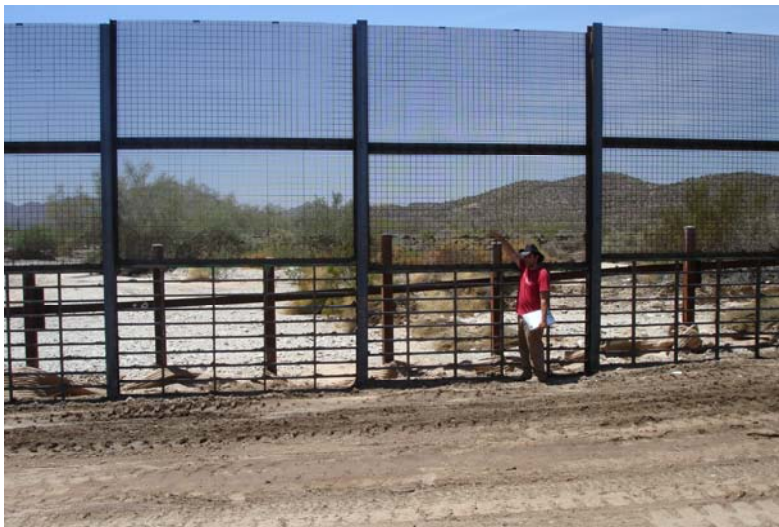
The same site as above, after flood debris was cleared (middle photo, July 16, 2008). Distance from the foundation wall of the fence to the high water line is over 7 feet.

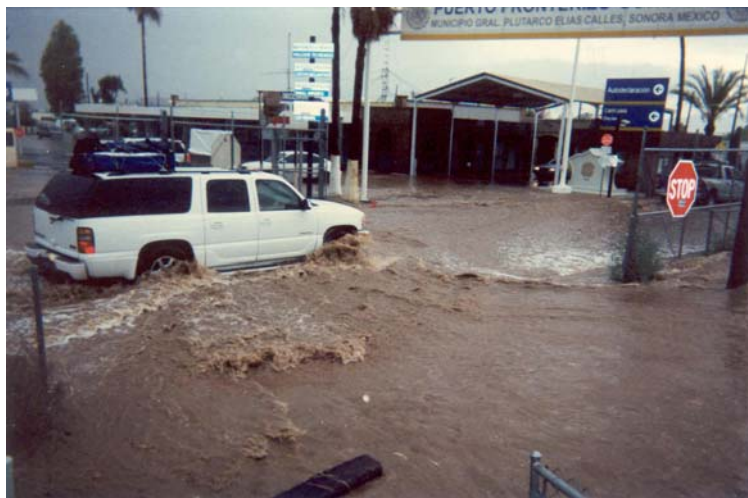
Figure 8 (left). Impounded by the pedestrian fence, floodwaters from Headquarters Wash, which normally flows from north to south, flowed to the east along the fence and into the Mexican Port of Entry in Sonoyta, Sonora. The white SUV is southbound into Mexico.

- Headquarters Wash flowed over 200 feet to the east along the pedestrian fence and through the international port of entry. It caused flood damage to private property, government offices and commercial businesses in Lukeville, Arizona, and Sonoyta, Sonora, Mexico (Figure 8).

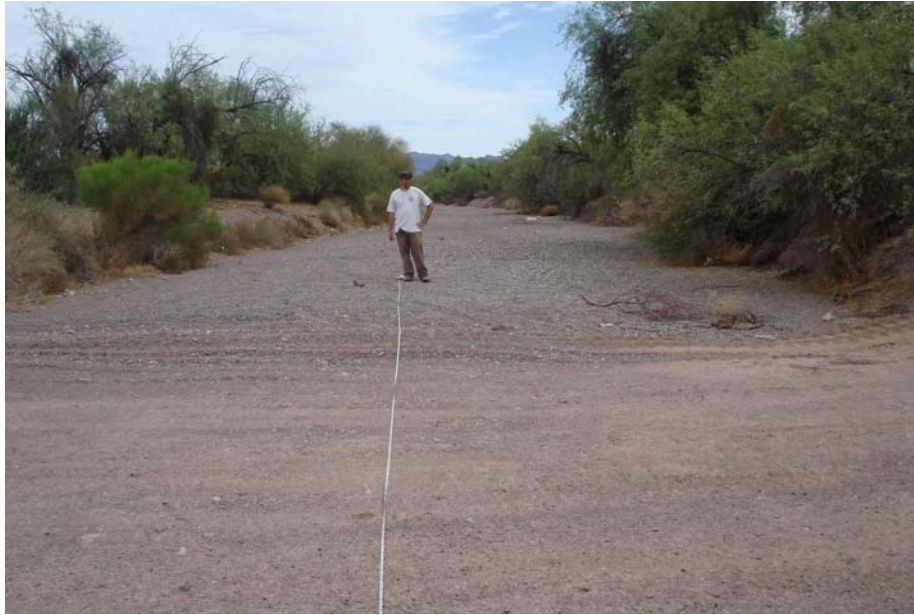
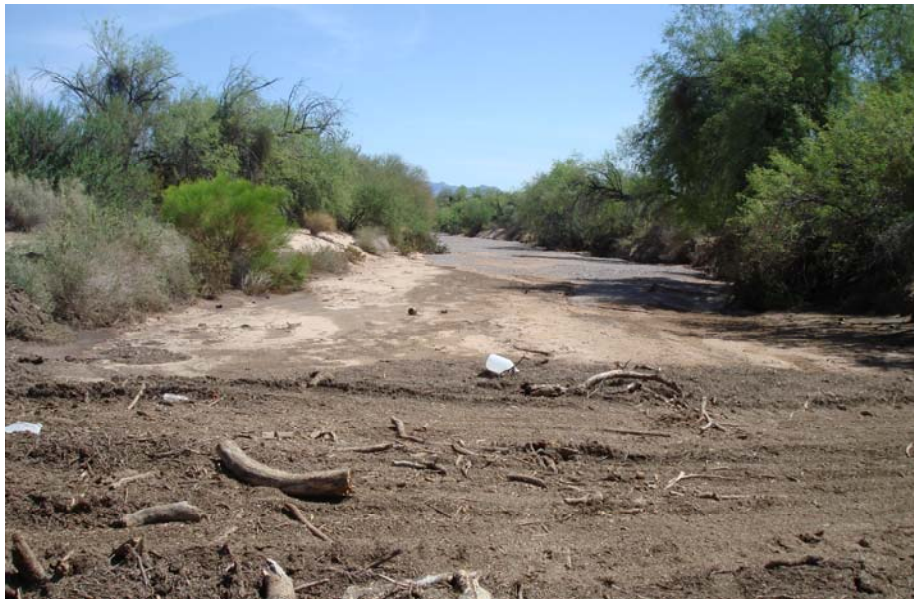
Notable fine sediment deposits were documented in Tejano Wash (Figure 9), Estes Wash, Dowling Wash, Victoria Wash, and Smugglers' Wash upstream from the patrol road on July 16, 2008. These deposits were also observed at Gachado and Headquarters washes, but the observation was not photographically recorded, as repeat photography did not occur at this sites.

Figure 9. Prior to fence construction (above), the bed of Tejano Wash (E16) was composed of coarse sand and gravel (NPS photo, 9 July 2008). After the flood (below), flood debris can be seen in the foreground of the same scene, and a new deposit of fine sediment can be seen in the midground (NPS photo, 16 July 2008).

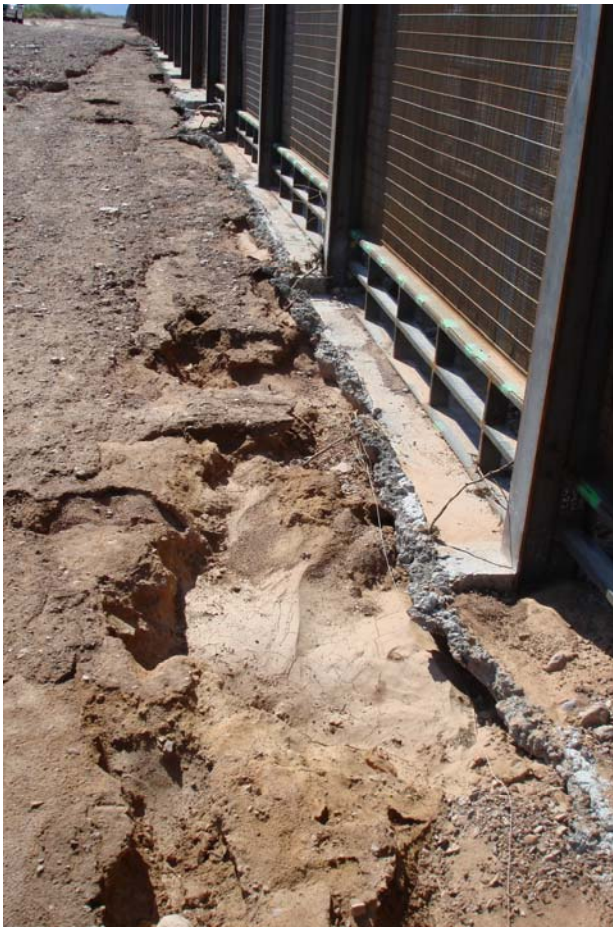
Scour that can be attributed to the pedestrian fence includes areas where lateral flows or backwater pools crossed the fence outside of natural drainages. Scour also occurred at the upstream side of the foundation wall (Figure 10).

Figure 10. Floodwaters flowed laterally along the pedestrian fence, causing scour at the foundation wall and erosion of the patrol road in places. (NPS wash 17, east of Lukeville, July 16, 2008).

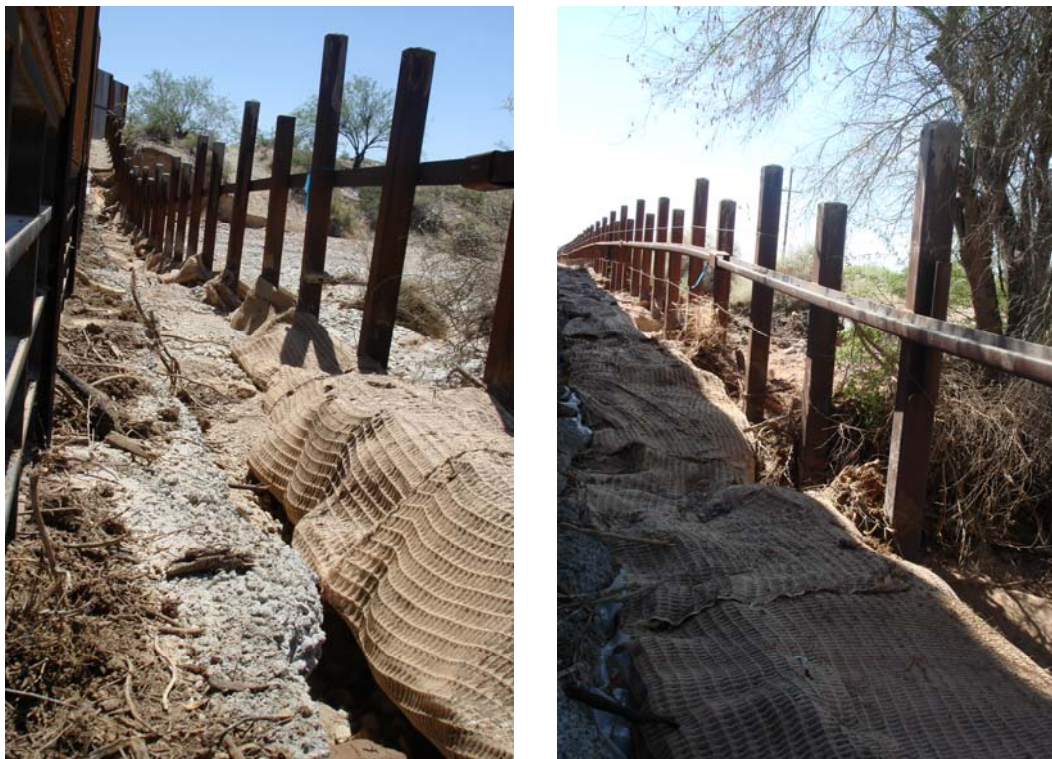
A water elevation rise of up to 7 feet at the pedestrian fence caused significant scour at the foundation wall and vehicle barrier on the downstream side. Erosion control fabric was displaced and in most large wash crossings is no longer functional (Figure 11).

Figure 11. Left: Downstream from the pedestrian fence, a 7-ft tall cascade of water caused downstream scour at Victoria Wash (NPS photo July 16, 2008). A Kiewit photo taken before construction (USACE 2008a) shows no scour at this site.

Right: At Estes Wash, floodwaters flowed along the foundation wall on the downstream side, causing scour at the vehicle barrier. At this site, the erosion control fabric remained in place, although exposed.
